Manhole Inspection Summary

Manhole # S17QQ1028MH

Insp Date: **2/8/07 11:17 AM**

Location Address: **SPRINGGARDEN DR**

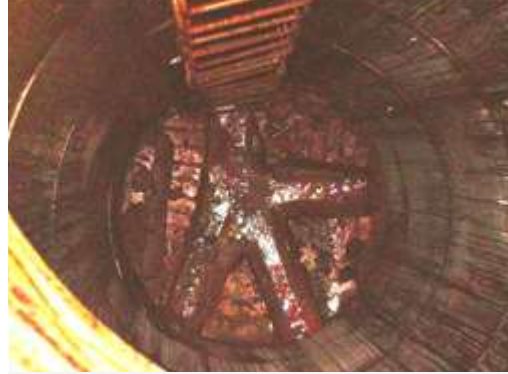
☐ Parged ☒ **Debris** (not Condition related)

☒ **Debris** (not Condition related)

Count: **23** Missing: **0** ☒ **Corroded**

Corroded steps. Bench and Channel debris.

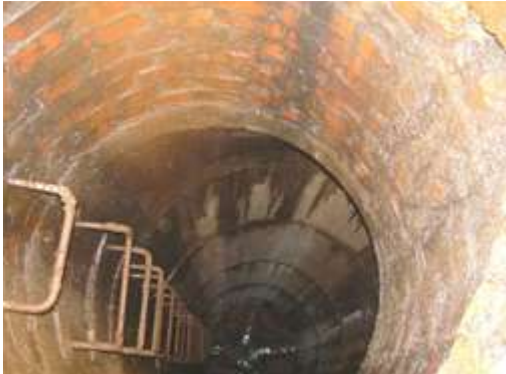
Defect

Infiltration: ☐ None ☒ **Joint** ☐ Cracks ☐ Mortar ☐ Roots ☒ **Wall**

Infiltration: ☐ None ☒ **Joint** ☐ Cracks ☐ Mortar ☐ Roots ☐ Wall

Adjustment, Corbel and Barrel infiltration.

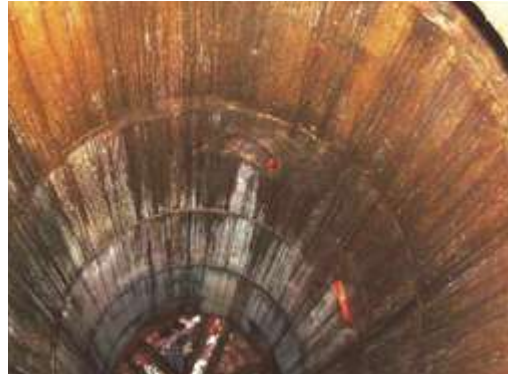
Defect

Corbel and Barrel infiltration - other side.

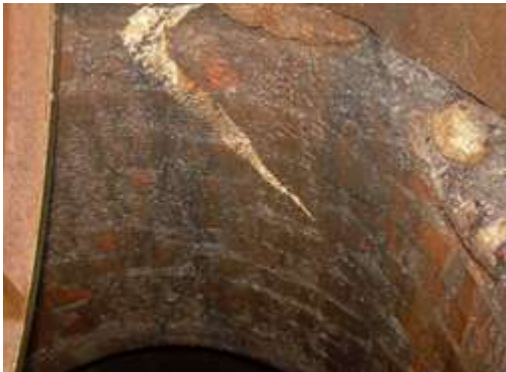
Defect

Frame leaks. Adjustment deterioration, loose brick and infiltration.
